# Spit Road MOSMAN

## Magnesite Damage to Concrete Floors

July / August  
2006

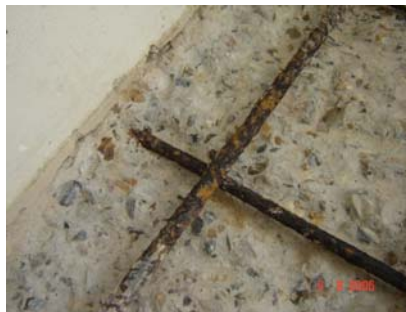
This phase identifies the area of damage and determines the extent.
