# Spit Road MOSMAN

## Magnesite Damage to Concrete Floors

July / August  
2006

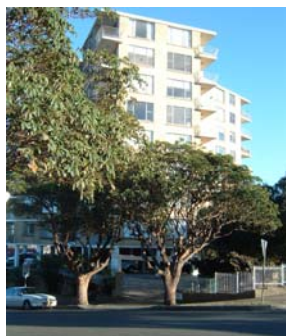
During renovation work to a number of units it was revealed that damage to concrete floors had occurred in the form of corrosion to reinforcing steel and subsequent spalling of the concrete cover.

**Linders Property Group**, on behalf of The Owners Corporation, commissioned **Strata Engineering Solutions** to inspect the building and prepare a report on the cause and the extent of damage to the floors and to provide the remedial solution. The cause of damage to the concrete floors was determined to be caused by moisture interacting with the magnesite topping on the floor.

Magnesite is a floor levelling and sound attenuating medium that was applied as a topping to floors in the 70's and 80's. In service it has been revealed that in contact with moisture it produced a weak solution of hydrochloric acid due to the presence of chlorides in the magnesite.

Over a long period of time the solution migrated through fine cracks in the concrete and acted on the reinforcing steel causing corrosion and subsequent expansion product of corrosive steel causing the concrete to delaminate and spall from the substrate. This in effect caused structural damage to the slab in that the effective area of reinforcing steel was reduced and the protective cover layer of concrete was damaged.
